**DEPARTMENT OF TRANSPORTATION**

Contract #: 04-0120F4Cty: SF/ALA Rte: 80 PM: 13.2/13.9File #: 69.28**WELDING INSPECTION REPORT****Resident Engineer:** Siegenthaler, Peter**Address:** 333 Burma Road**City:** Oakland, CA 94607**Report No:** WIR-017839**Date Inspected:** 07-Nov-2010**Project Name:** SAS Superstructure**OSM Arrival Time:** 700**Prime Contractor:** American Bridge/Fluor Enterprises, a JV**OSM Departure Time:** 1900**Contractor:** Zhenhua Port Machinery Company, Ltd (ZPMC), Changxing Island **Location:** Shanghai, China**CWI Name:** Li Yang**CWI Present:** Yes No**Inspected CWI report:** Yes No N/A**Rod Oven in Use:** Yes No N/A**Electrode to specification:** Yes No N/A**Weld Procedures Followed:** Yes No N/A**Qualified Welders:** Yes No N/A**Verified Joint Fit-up:** Yes No N/A**Approved Drawings:** Yes No N/A**Approved WPS:** Yes No N/A**Delayed / Cancelled:** Yes No N/A**Bridge No:** 34-0006**Component:** OBG Segments**Summary of Items Observed:**

Segment 11DW/11EW

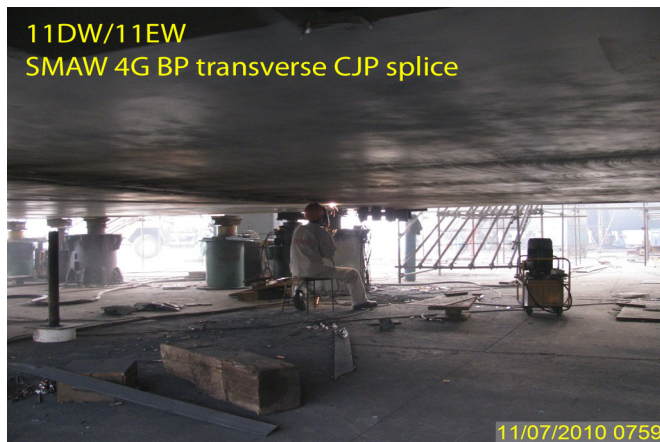
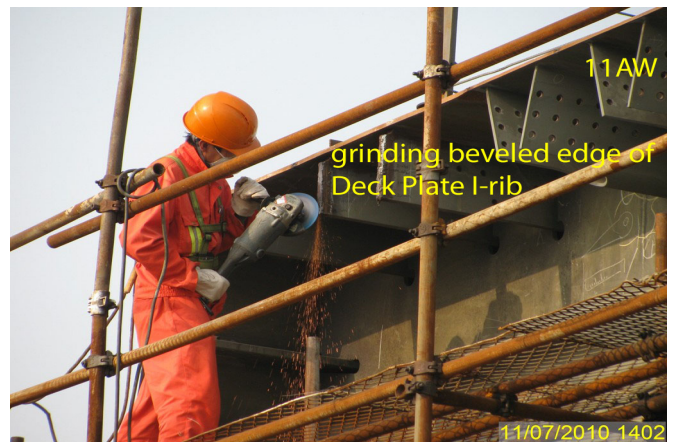
Unless otherwise noted, all work observed on this date appeared to generally comply with applicable contract documents.
